TEST REPORT

Report No: HY/2013/90151

Type of Product: Ball Pen

Migration of Certain Elements

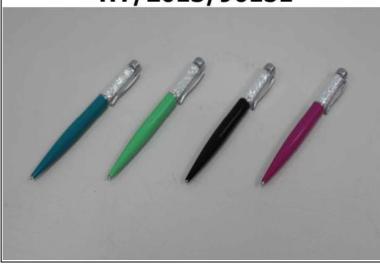
HY/2013/90151

Sample picture (As received)

- 1. Peach coating of sample. (cover of penholder)*
- 2. Green coating of sample. (cover of penholder)*
- 3. Blue-green coating of sample. (cover of penholder)*
- 4. Black coating of sample. (cover of penholder)*
- 5. Silver colored metal of sample. (pen clip)*
- 6. Silver colored metal of sample. (pen clip)*
- 7. Transparent plastic of sample. (on penholder)*
- 8. Black ink of sample.*
- 9. Black plastic of sample. (on refill)*
- 10. Transparent plastic rube of sample. (refill)*
